# Manhole Inspection Summary

Manhole # S61K\_\_007MH

Insp Date: **7/8/08 11:40 AM**

**Location** Address: **rear 900 s ponca st**

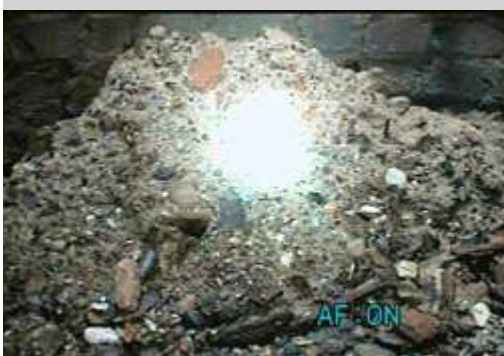
Defect 3

Condition: ☐ Sound ☐ Cracked ☐ Root Intrusion ☐ Deteriorated ☐ Leaks ☒ **Debris**

bench debris

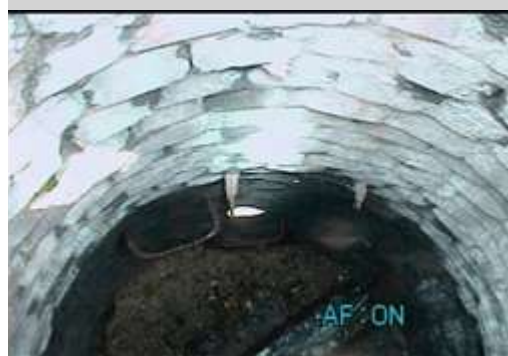
Defect 2

Infiltration: ☐ None ☒ **Joint** ☐ Cracks ☒ **Mortar** ☐ Roots ☐ Wall

**Steps** Count: **4** Missing: **2** ☒ **Corroded**

corbel joint infiltration and corroded steps

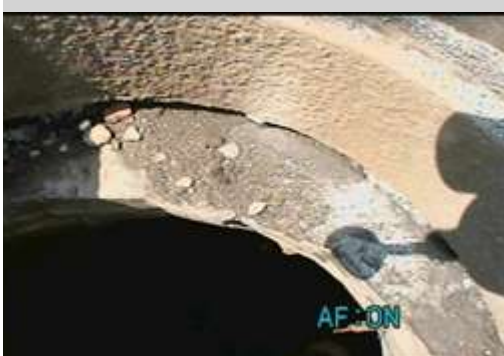
Defect 1

**Frame** Offset: **4** (in.) Condition: ☒ Sound ☐ Cracked ☐ Leaks

offset
